Incident Report: Davy Crockett Emergency Response

Update as of Oct. 25, 2011

DAVY CROCKETT VESSEL REMOVAL COMPLETED

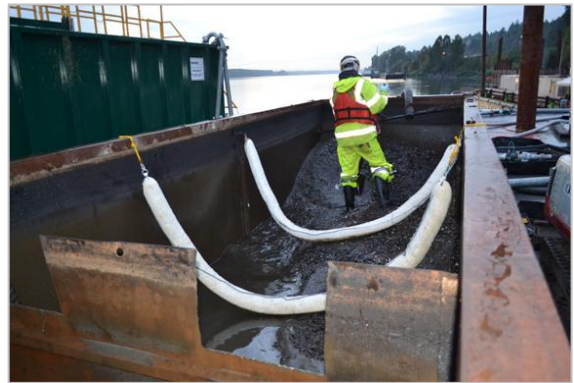
Worker examining sediment collected during dredging operation at the end of the day. (10/13/11)

The final phase of the Davy Crockett deconstruction project begins today as workers start to remove the metal sheetpile cofferdam. Dive operations concluded on Saturday, October 22 after 38 days of dredging operations to remove deconstruction debris and contaminants inside the cofferdam. A total of 85.5 cubic yards of sediment containing metal slag and scale (metal “flakes”) was removed. In addition, dive teams recovered more than 1,500 spent underwater cutting rods and 7,700 pounds of miscellaneous pieces of scrap metal. During the dredging operations, a total of 11.6 million gallons of water was treated in the on-site water filtration system.

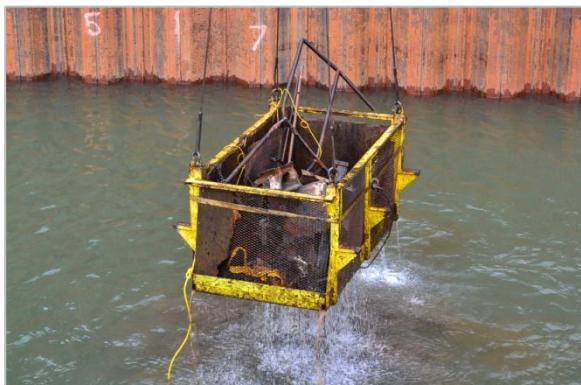
Pieces of miscellaneous scrap metal being lifted from the river bottom inside the cofferdam. The metal is being collected by divers during dredging operations. (10/5/11)
